**Repairs to the  
Sears Tower  
at the Harvard Observatory  
Cambridge, Massachusetts**

**Boston Building Consultants  
79 Milk Street, Suite 800  
Boston, Massachusetts 02109**

**September 20, 1991**

Re: Sears Tower  
Harvard Observatory, Cambridge, MA  
BBC Job No. 91047

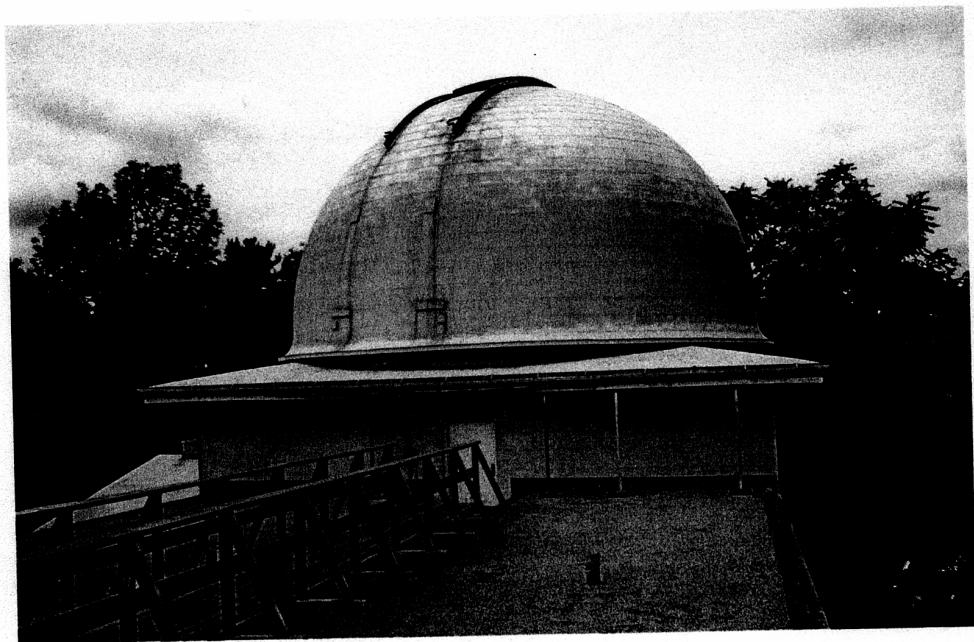
Photo 1

The copper cladding of the upper half of the dome was reportedly replaced in 1955. It appears to be watertight and in good condition. The copper cladding on the lower portion of the dome is pitted with local corrosion which can be seen as dimples through the silicone coating (Photos 1 & 3).

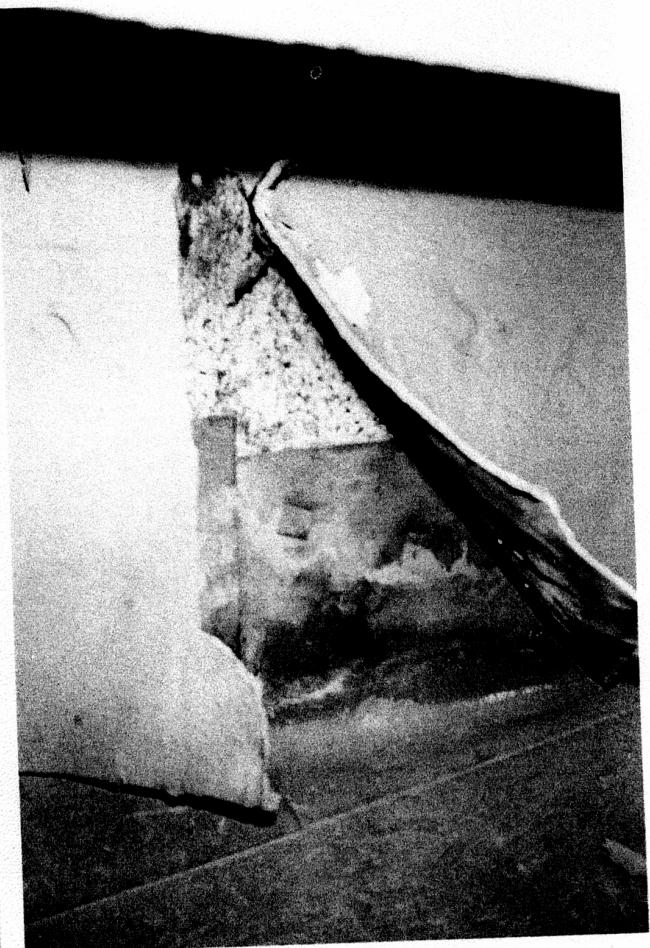
Photo 6

The junctions of the apron and the building are flashed with lead. This appears to be original material. It has torn in several locations and appears to be quite brittle (Photo 6).

The lead counterflashing at the base of the dome appears to be the original material. It is torn in several locations and appears to be brittle. In a complete reroofing project, the counterflashing should be completely backed up with a rubber membrane and the lead repaired or replaced as necessary.

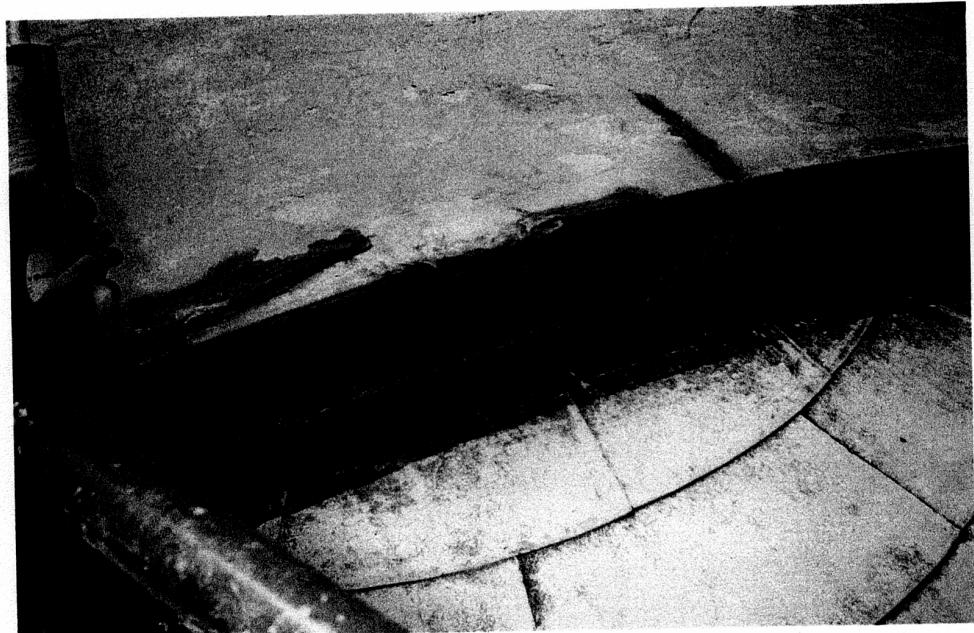
Photo 7

The shutters are arranged so that they extend to three degrees beyond the zenith to three degrees below the horizon. The two upper shutters are 9 feet long each and the three lower shutters are approximately 3 feet long. They are all about 5 feet wide. The lower three move in copper sheathed wood tracks similar to standard double hung window sash. The upper shutters travel along channel iron tracks secured to the dome (Photos 7 & 9).

The shutters are inoperable and are all caulked shut at the present time. The fiberglass cladding of the upper shutters has failed by splitting. Older cracks in the fiberglass cladding of these shutters have been temporarily sealed with roofing mastic but we observed fresh cracks near the peak of the dome (Photo 7). The top coating over the fiberglass base material has failed. The steel tracks for the upper shutters are heavily rusted (Photo 9).

If the shutters are to operate, I believe that the shutters will all have to be reclad in copper and reflushed. The sliding mechanisms will have to be rebuilt, the upper shutters extended and redesigned to shed water better, and an internal gutter system installed to collect water which finds its way through the individual leaves of the shutter.
