**CONDITION SURVEY**

**SEARS TOWER  
HARVARD COLLEGE OBSERVATORY  
CAMBRIDGE, MASSACHUSETTS**

**HARVARD COLLEGE OBSERVATORY  
60 GARDEN STREET  
CAMBRIDGE, MASSACHUSETTS**

**May 1990  
Project #5334**

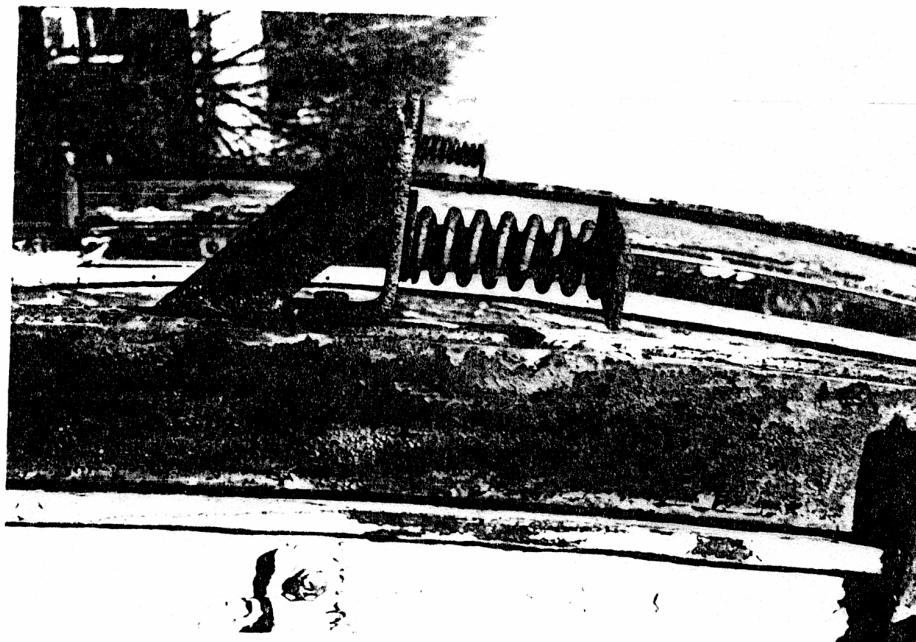
According to present building maintenance personnel, a severe leak exists at the dome's retractable door. Inspection of the door revealed several past repairs to the door's flashing. The existing flashing materials are delaminating from the door and several holes and splits exist. Also, the door's running track and associated mechanisms are severely rusted.

**Rusted I Beam Running Track for Dome's Retractable Door**

In addition to the roof replacement, all necessary door frame and mechanism repairs and/or replacements which must be performed from the exterior should be addressed at that time.

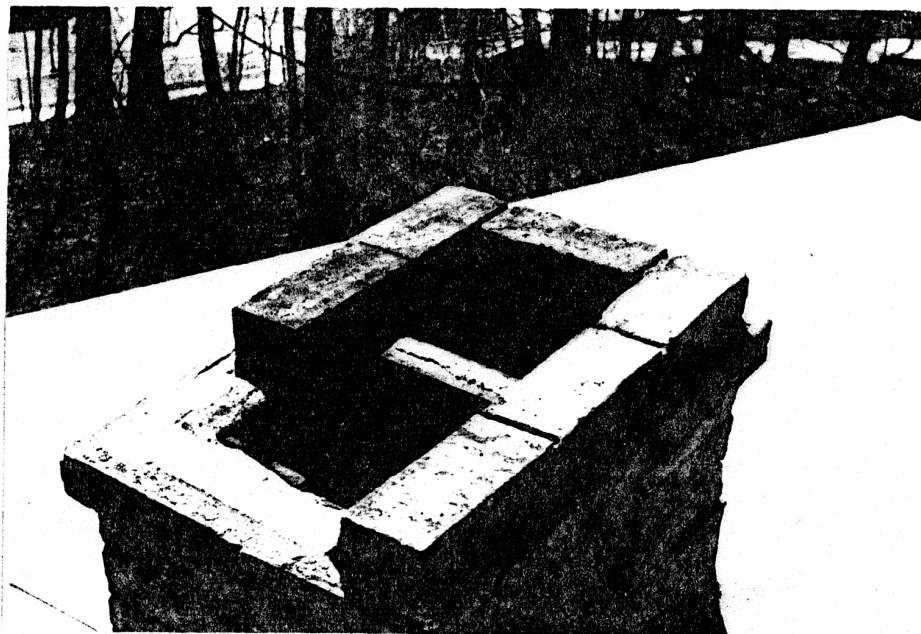
Inspection of the dome and adjacent peaked roof revealed the two roof areas to be in varying conditions. The smaller peaked roof at the rear of the building is generally in worn but functional condition. This roof section is not leaking at this time. Two items worth noting, are the conditions of the masonry chimney and the wood cornice work at the roof eaves. Several bricks are missing at the chimney cap and the paint on the exposed wood cornice is peeling thus exposing sections of the wood.

**Missing Bricks at Chimney on Small Copper Roof  
Adjacent to Dome Roof**

The peaked roof is generally in satisfactory condition and can be expected to remain functional for a minimum of 3 - 7 years if it is properly maintained; however, the existing chimney should be repaired and the cornice repainted. The estimated cost of these two items is approximately \$3,500.00.

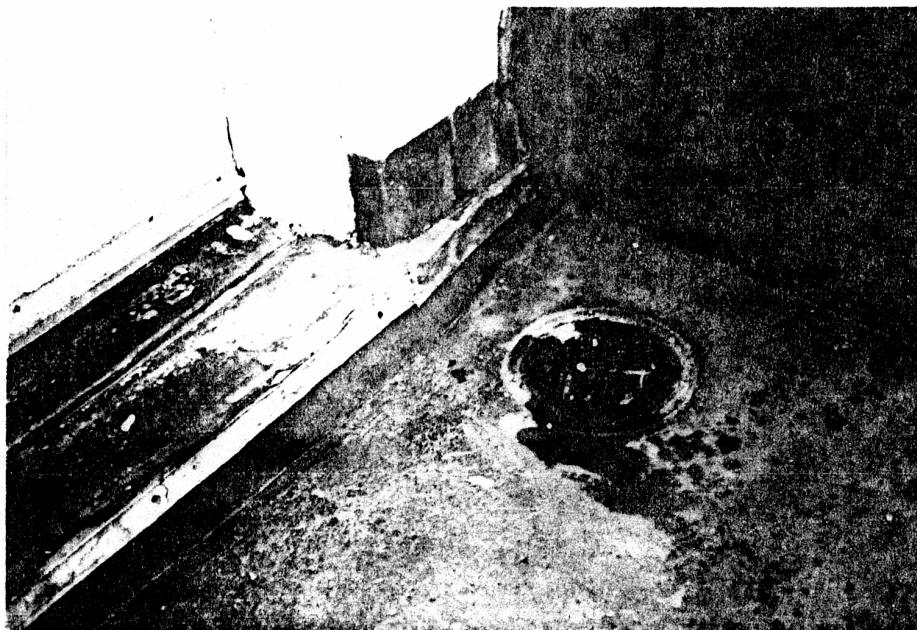
Inspection of the building's interior revealed a severe roof leak in the stairwell between the B Building and Sears Tower directly under an access door and adjacent exterior stairwell where the B Building abuts the Sears Tower. The wood blocking at the perimeter of the exterior stairwell is exposed and severely deteriorated and the stairwell's drain clogged with debris. Also, the door requires repainting and the installation of weatherstripping at the door's base.

**Clogged Drain at Roof Top Stairwell**

1. Repair all edge and base flashing deficiencies.
2. Replace deteriorated wood and install new replacement flashing, repaint door, install weatherstripping, and clean drain at exterior stairwell.

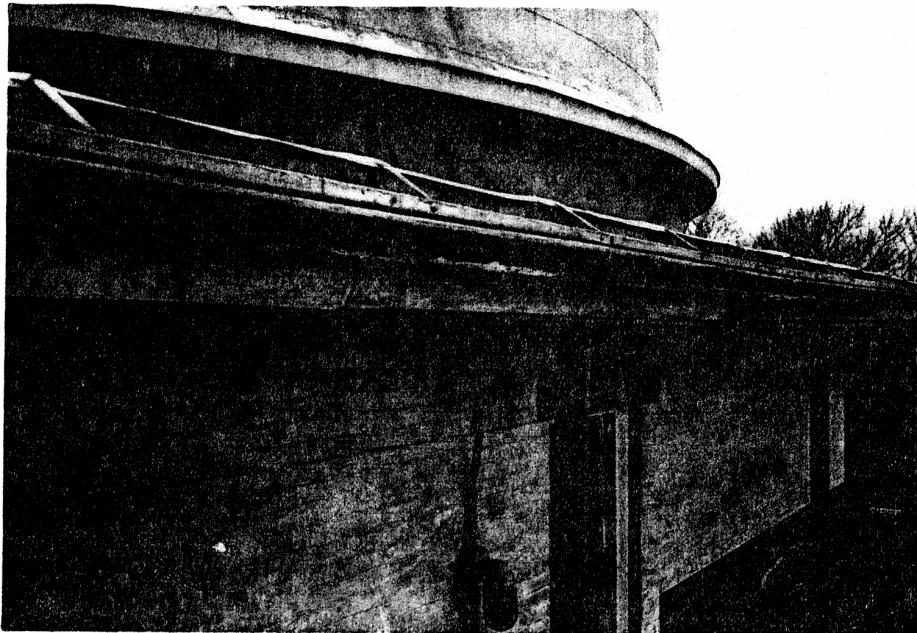
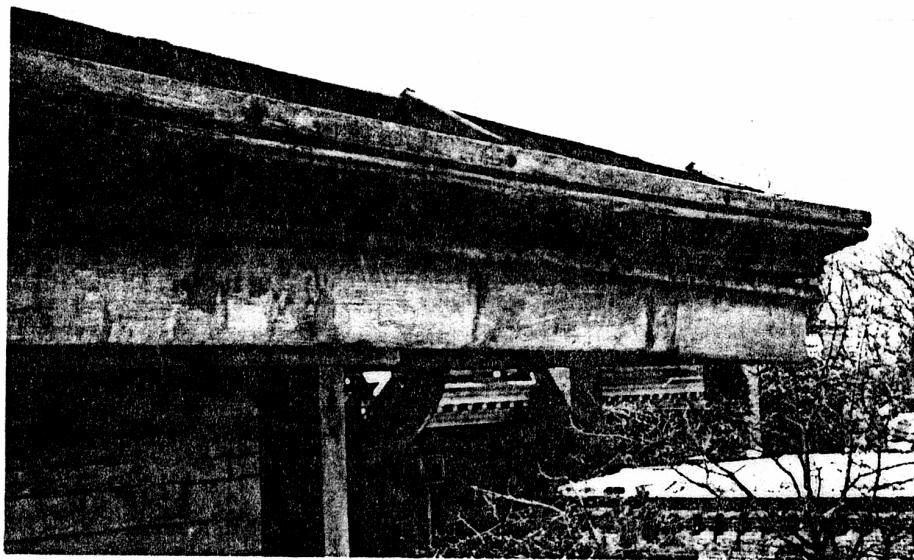
The condition of the dome roof system varies from worn but functional at the dome portion of the roof to poor at the shelf portion (i.e., water table). The dome's water table encompasses the entire dome and includes a copper gutter to accommodate roof run off. The section of the watertable's cornice adjacent to the B Building's roof is underpinned with wood supports. The wood decking, fascias, and cornice work in this area is severely deteriorated, apparently resulting from water penetration into the water table and/or gutter. It is impossible to determine the condition of structural wood components of the shelf until the the copper roofing and flashing are removed. However, it does appear that the structure is salvageable and the severe deterioration restricted to the wood decking, fascia and cornice work.

The gutter in this area is severely deteriorated with several detached and missing support straps. The gutter seams are also in poor condition and in some cases open to water penetration. Also, all of the existing gutter downspouts are in poor condition.

**Severely Deteriorated Gutter and Cornice at Dome Eave**

The dome roof and underlying watertable are in varying conditions. At a minimum the existing copper flashing and gutters at the water table and all deteriorated wood as well as the retractable door's cover should be removed and replaced with new matching materials. It is difficult to estimate an accurate cost for these items as the extent of deteriorated wood is unknown; however these costs may exceed \$35,000.00.

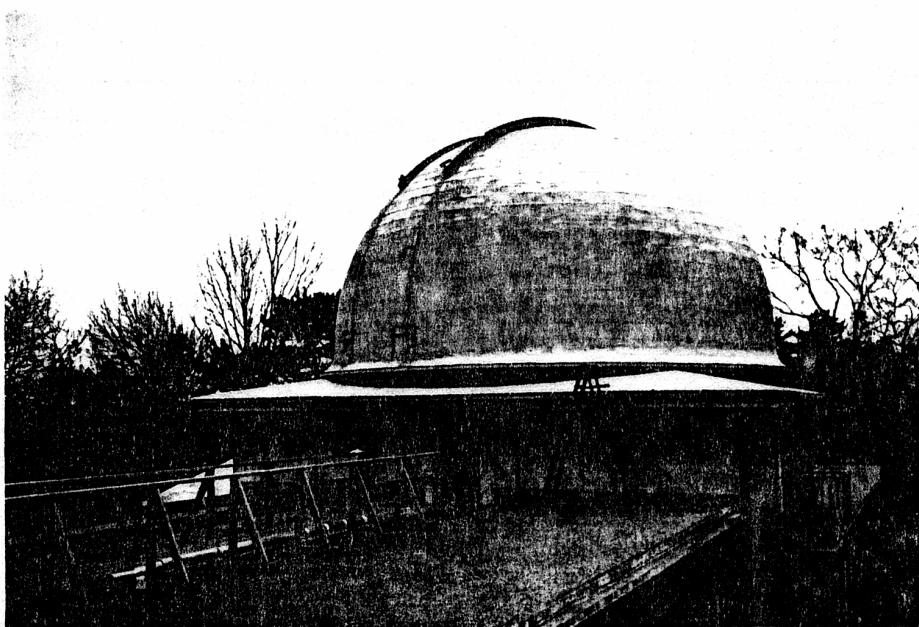
**Section of Dome Cornice Underpinned to Prevent Collapse**
