# STRUCTURAL TECHNOLOGY, INC.

December 26, 1989

Re: Harvard College Observatory - Structural Report

On December 13, 1989 the author conducted a brief structural inspection of the structure designated as the Harvard College Observatory located in Cambridge, Massachusetts.

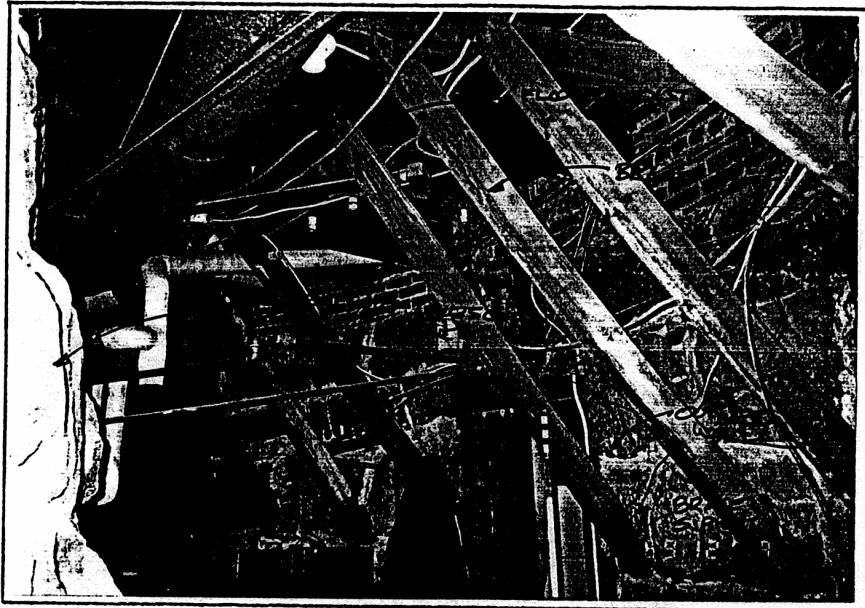
Elements of the first level floor system are illustrated by Photograph No. 1. Our comments concerning this level are as follows:

1. The radially located floor joists extend from the exterior wall to the interior granite telescope foundation. They were intended to be cantilevered from the braces shown in Photograph No. 1 in effect forming a bracket. The floor joist connection at the exterior wall is shown in Photograph No. 2. Since a tension tie does not exist at this location, the floor boards act somewhat as a series of compression rings to resist the inward movement of the cantilevered bracket.

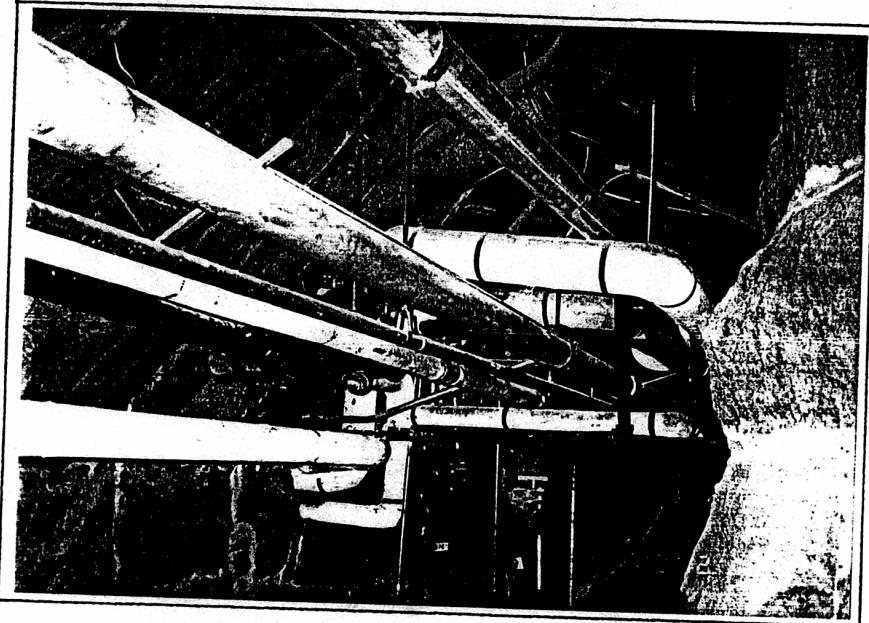
Photograph No. 3

2. Two conditions have altered the loads which the floor must now carry. As shown in Photograph No. 3. extensive piping and ductwork materials are supported directly from the floor joists and/or brackets. More importantly the first level has undergone a change of use and has become, in our opinion, a main egress corridor. The present Code would in effect require that this floor be capable of resisting 100 pounds per square foot of load in addition to the work hung from it below.

4. A far more rigorous structural investigation and analysis is required to ascertain whether the present system can be utilized to support the Code stipulated loads but based upon present information, we feel that reinforcement is required. Two approaches or combination thereof are suggested.

A series of segment beams supported on columns could be added to support the interior end of the floor joist. Alternatively, the existing system could be reinforced to carry the additional loads. We favor this latter approach since it follows the original design intent; however, the brackets support beams located at the corners of the structure will most certainly require replacement or modification.

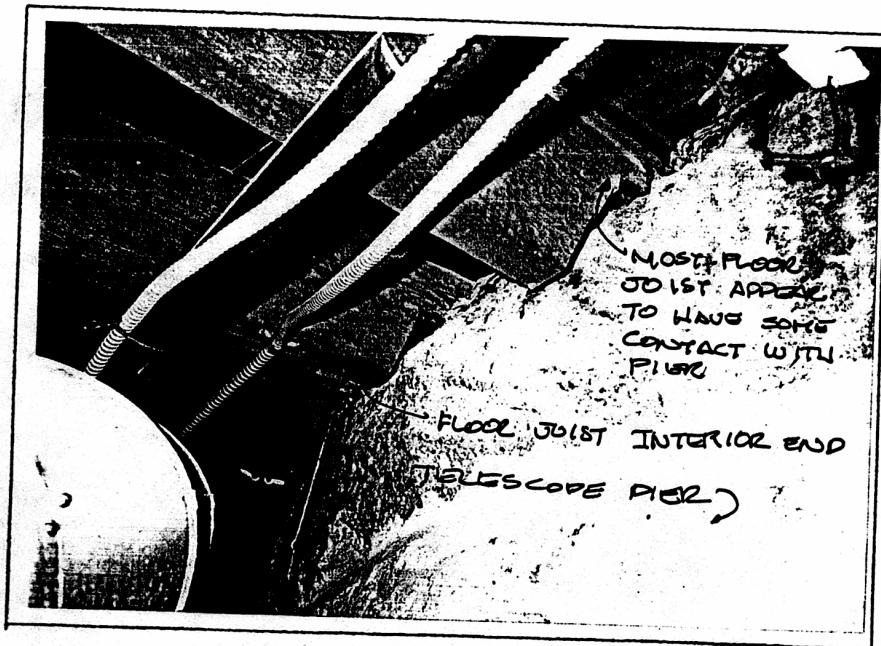
3. Evidence exists that the floor has sagged and that it is not functioning as originally intended. Such sag would have occurred as the wood members underwent shrinkage or as loads were increased over the original quantities. Photograph No. 4 indicates that many of the floor joists are now in fact supported by the telescope support masonry. Furthermore, a cementitious levelling slab was placed on the floor surface, presumably to correct problems caused by deflection.

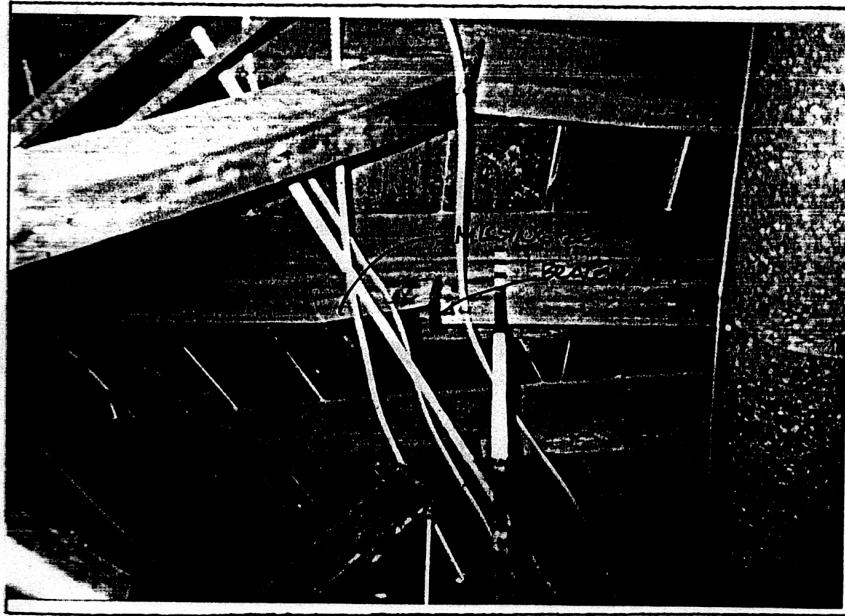
Photograph No. 6

A number of loose conditions were observed at the exterior brace supports such as that shown in Photograph No. 5. This would occur if the interior portion of the floor joist was supported by the telescope masonry rather than being free of it. Many braces have been wedged and several are missing as

shown in Photograph No. 6.

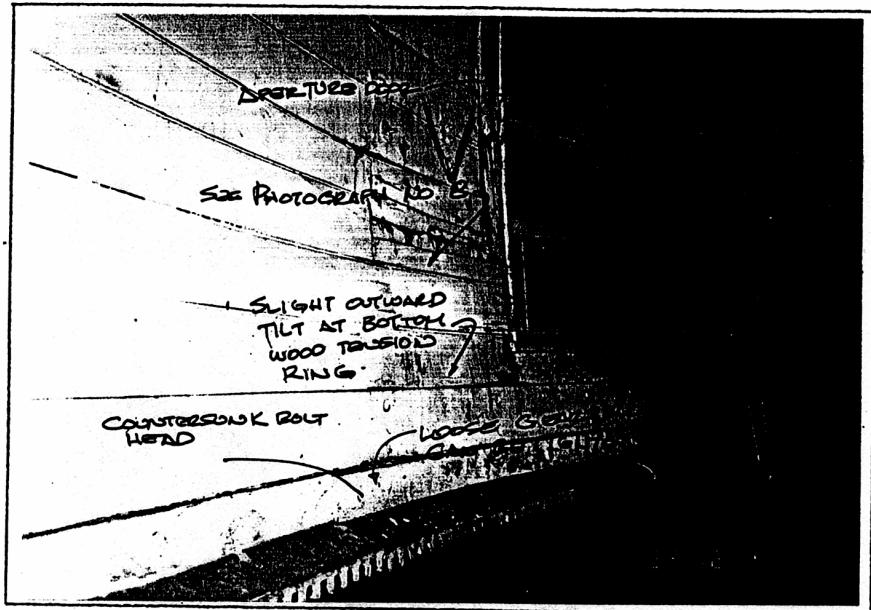
Photograph No. 7

2. Very slight surface rot was observed at the vicinity of the aperture door at the location designated by Photograph Nos. 7 and 8. No rot was observed at other locations.

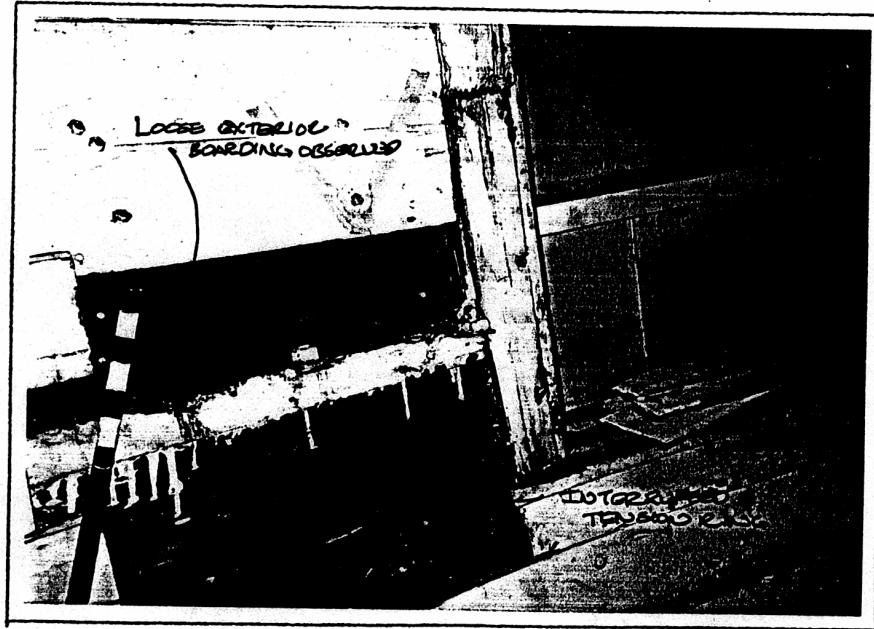
Photograph No. 8

4. The dome rests upon a laminated tension ring which is shown in Photograph No. 8. The aperture door was installed in such a manner that a portion of the ring was severed. Although a slight tilt in the ring was observed, the ring is

supported upon and bolted to a cast iron track and the dome is sheathed on two sides with wood boarding. Based upon present information and the fact that the dome loads are low, we do not feel repair of this defect is warranted.

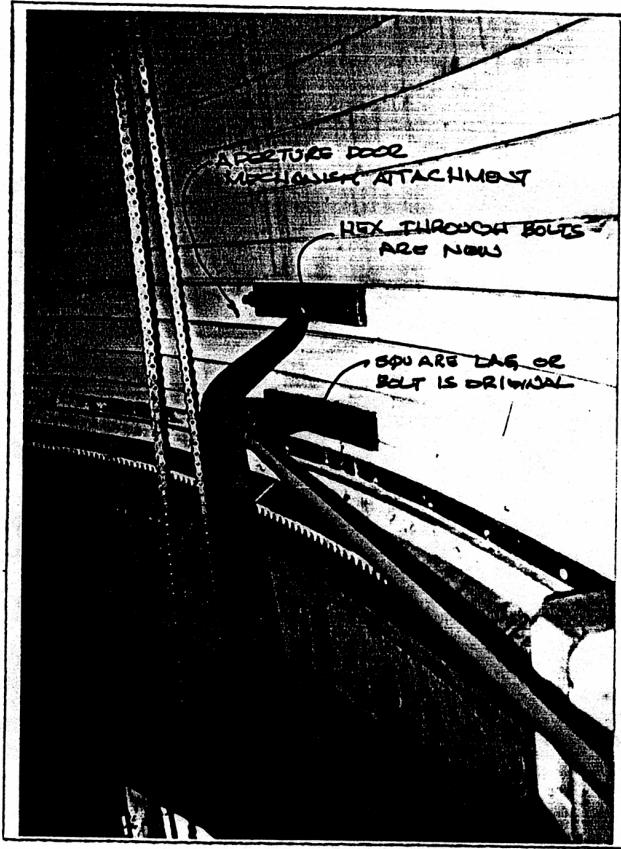
Photograph No. 9

6. Concern was expressed regarding the iron aperture door mechanism and its attachment to the dome. This assembly is shown in Photograph No. 9. We observed that a number of original square head lag screws or bolts had been replaced with new hex head through bolts.

As long as the mechanism is used solely for the purpose for which it was designed, we feel, based upon present information, that it can adequately carry the aperture door loads. However, since the mechanism must travel with the dome, its lower portion is not supported horizontally. Significant leverage could be developed to damage the assembly and overstress the bolts if, for example, a number of individuals were allowed to lean against the mechanism.

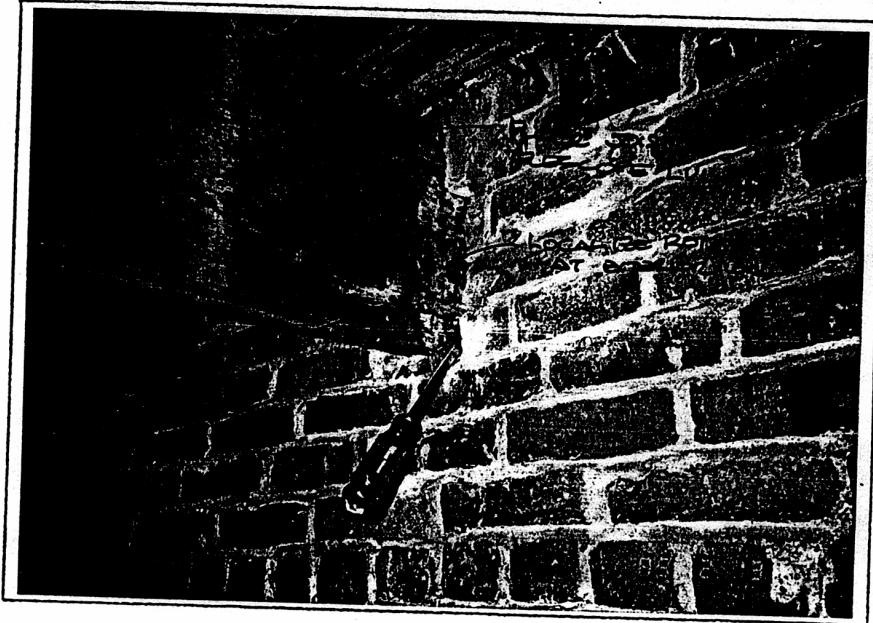
2. As shown by Photograph No. 11 one area of localized floor joist rot was discovered at the exterior wall. The condition could be corrected by attaching a supplementary support to the face of the brick.

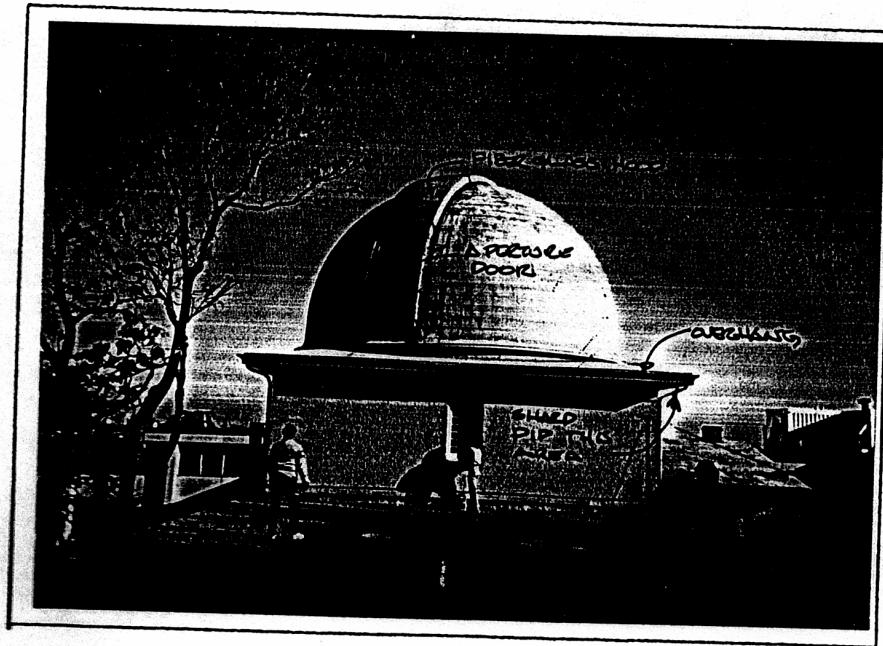
Photograph No. 12

1. Elements of the exterior surface are shown in Photograph No. 12. We observed significant sag at the underside of the overhang. As shown by Photograph No. 13 sections of this area have been shored. This situation has resulted more from nail detachment and flashing failure than from a deterioration of the structural members which support the roof immediately above the overhang. We estimate that repair and relining of the gutter combined with new flashing and support for the underside will cost approximately \$20,000.
