PLAN FOR RESTORATION OF  
THE SEARS TOWER  
AND  
CONTENTS

## **RENOVATION OF THE SEARS TOWER, THE 15" TELESCOPE, AND THE ROTUNDA**

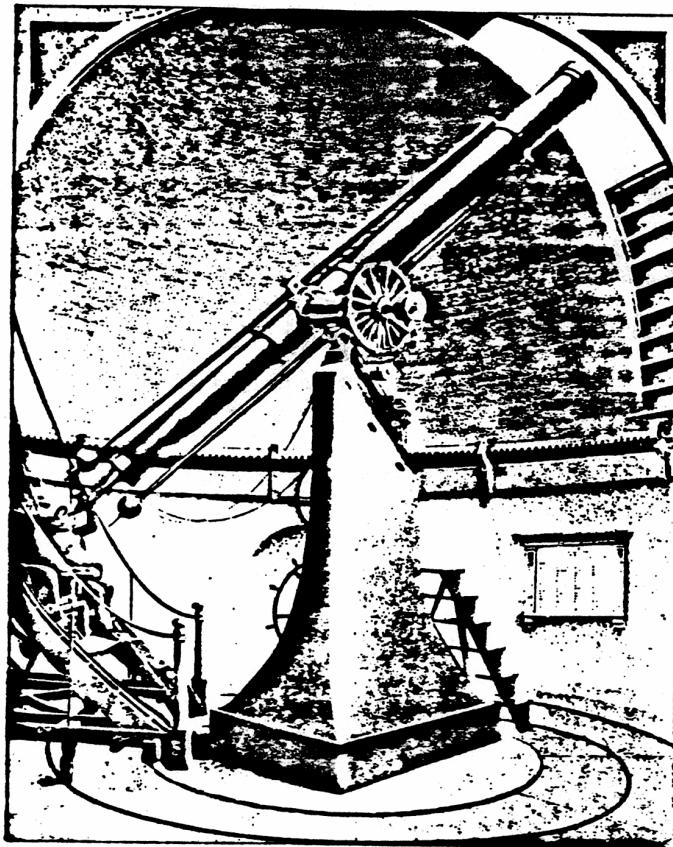
Figure 2: The 15" telescope. The lower part of the observer's chair can be seen on the left.

The Observer's Chair is in deteriorated condition, but can be easily stabilized and refurbished to a functional display condition. It is not appropriate to plan substantial use of the chair given its historical value, nor to renovate it to support such use. It was designed and built to be used by a limited few skilled observers, not the general public.
